## Photographs of good & poor control practice

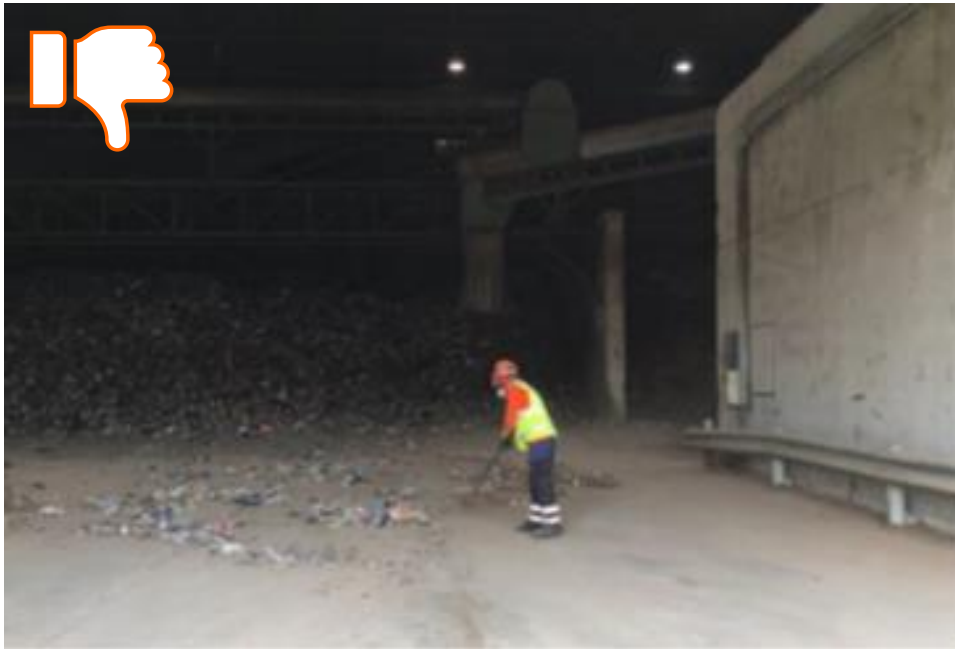
Dry sweeping (even though RPE is worn) this could have been undertaken using a shovel loader (dry sweeping was subsequently stopped by the company)

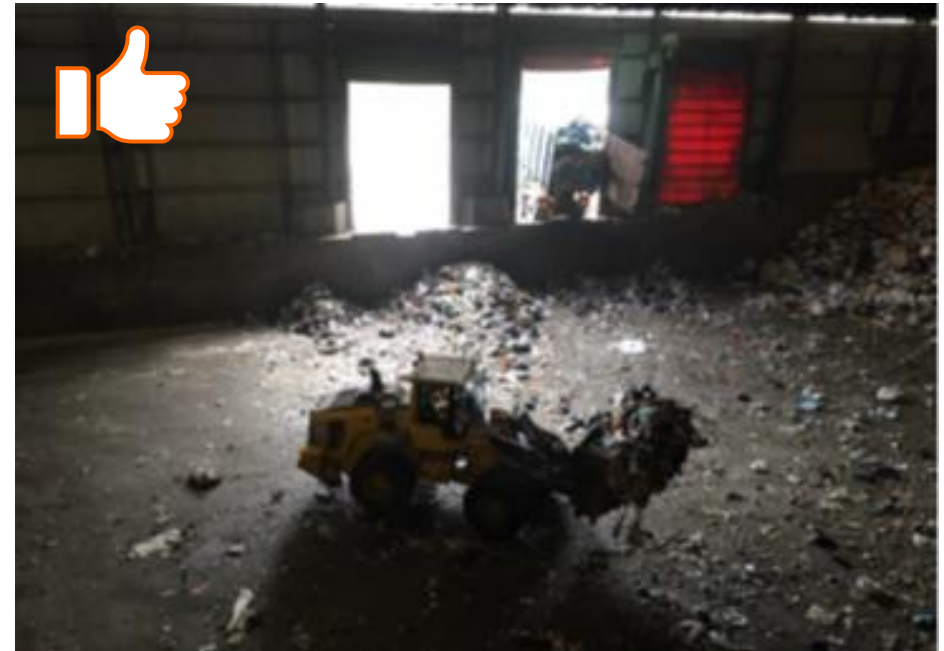
Tipping hall where waste is transferred to sorting conveyor by mechanical shovel loader (cab is HEPA filtered and subject to maintenance by hire company every 100hrs of use)

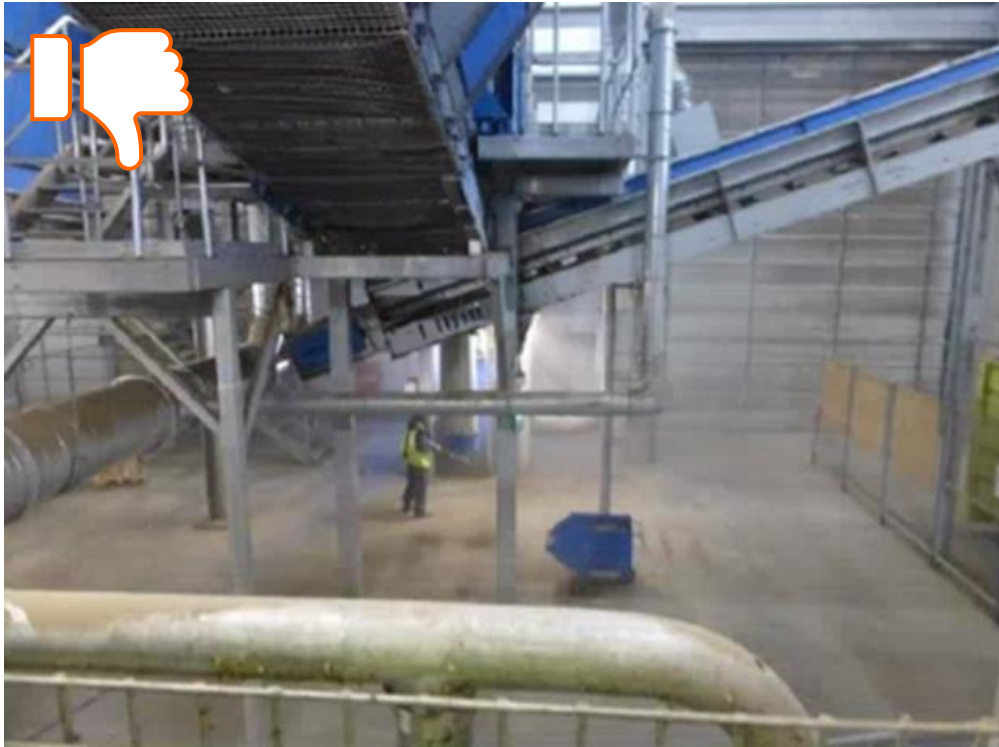
**Cleaner blowing down floor using compressed air (this is simply displacing the dust/debris not cleaning) and is worse than dry brushing!**

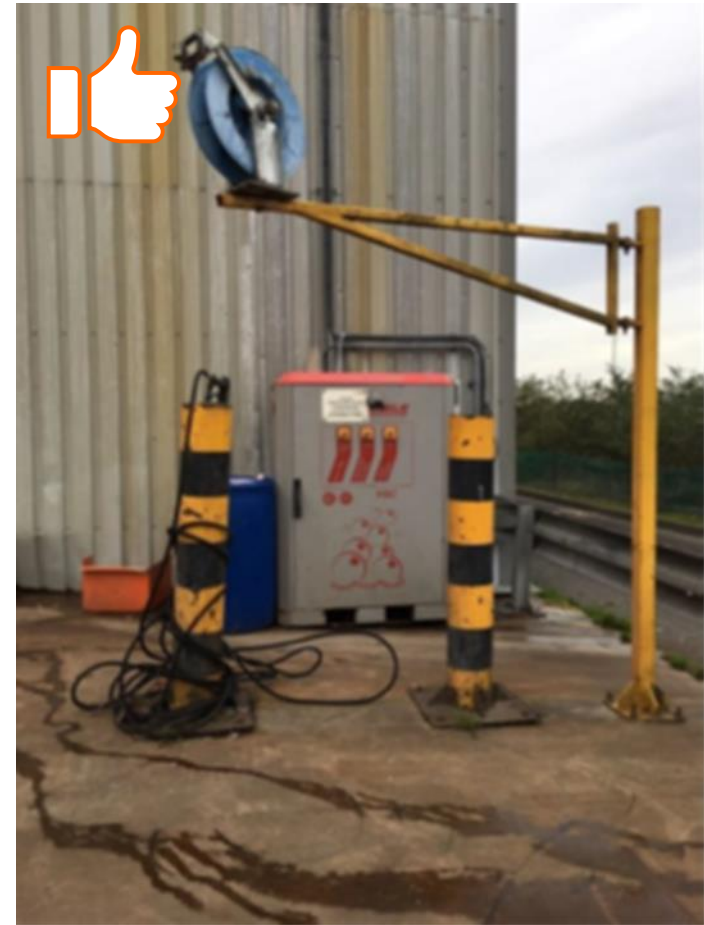
**Steam washer to clean heavy plant used in waste/compost tipping and processing halls**

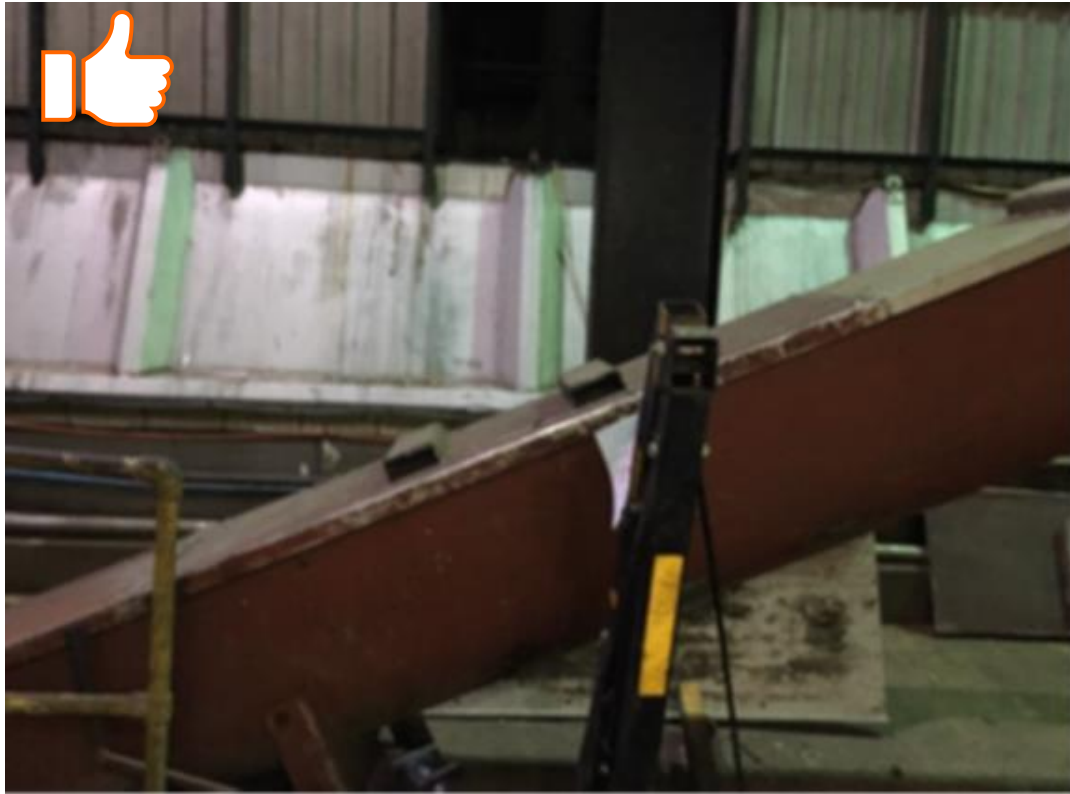
Fully enclosed auger transporting food waste
